ROUTE 20 PEDESTRIAN CROSSING

Carrie Shephard, Resident Engineer
Troy Austin, Transportation Operations Director

April 27, 2026

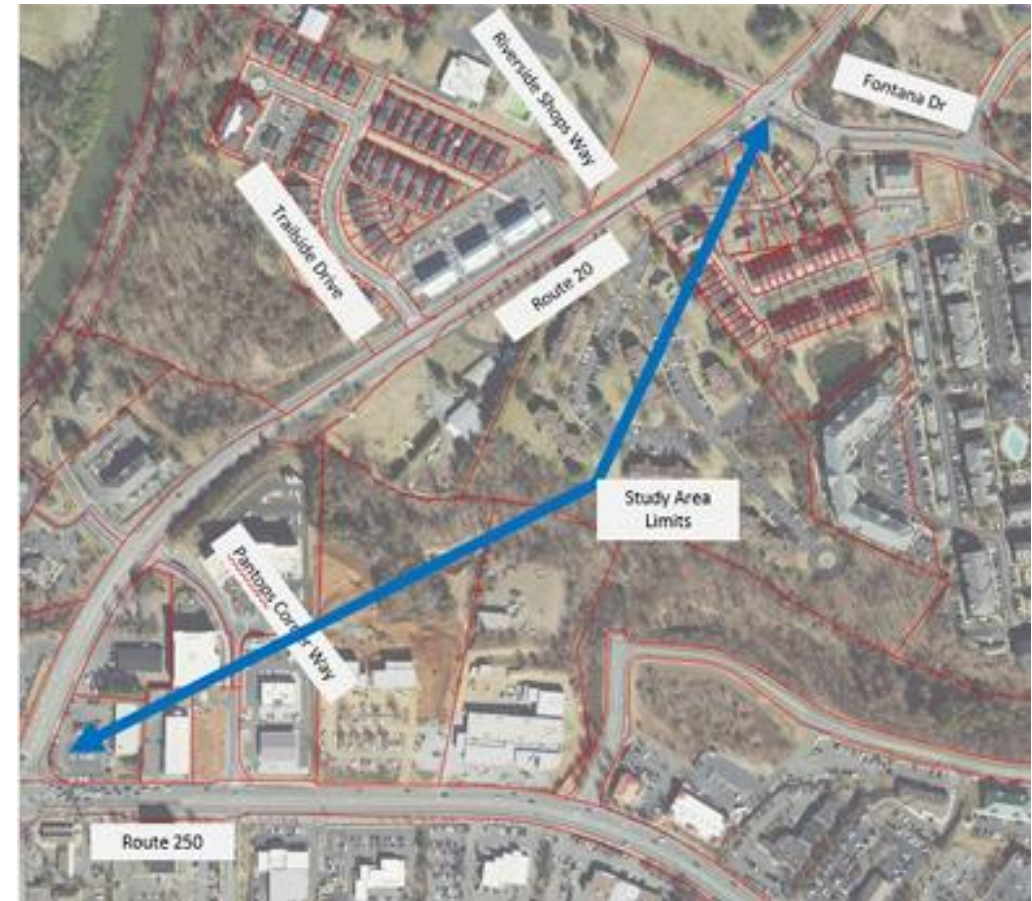
- Study area is Route 20 (Stony Point Road) between Route 250 (Richmond Road) and Fontana Drive/Elk Drive
- Study area falls within the County's Pantops Planning area and envisioned to be a "boulevard" with pedestrian amenities and landscaping
- Abutting land of commercial and residential, along with a bus stop, highlight the need for a safe pedestrian crossing

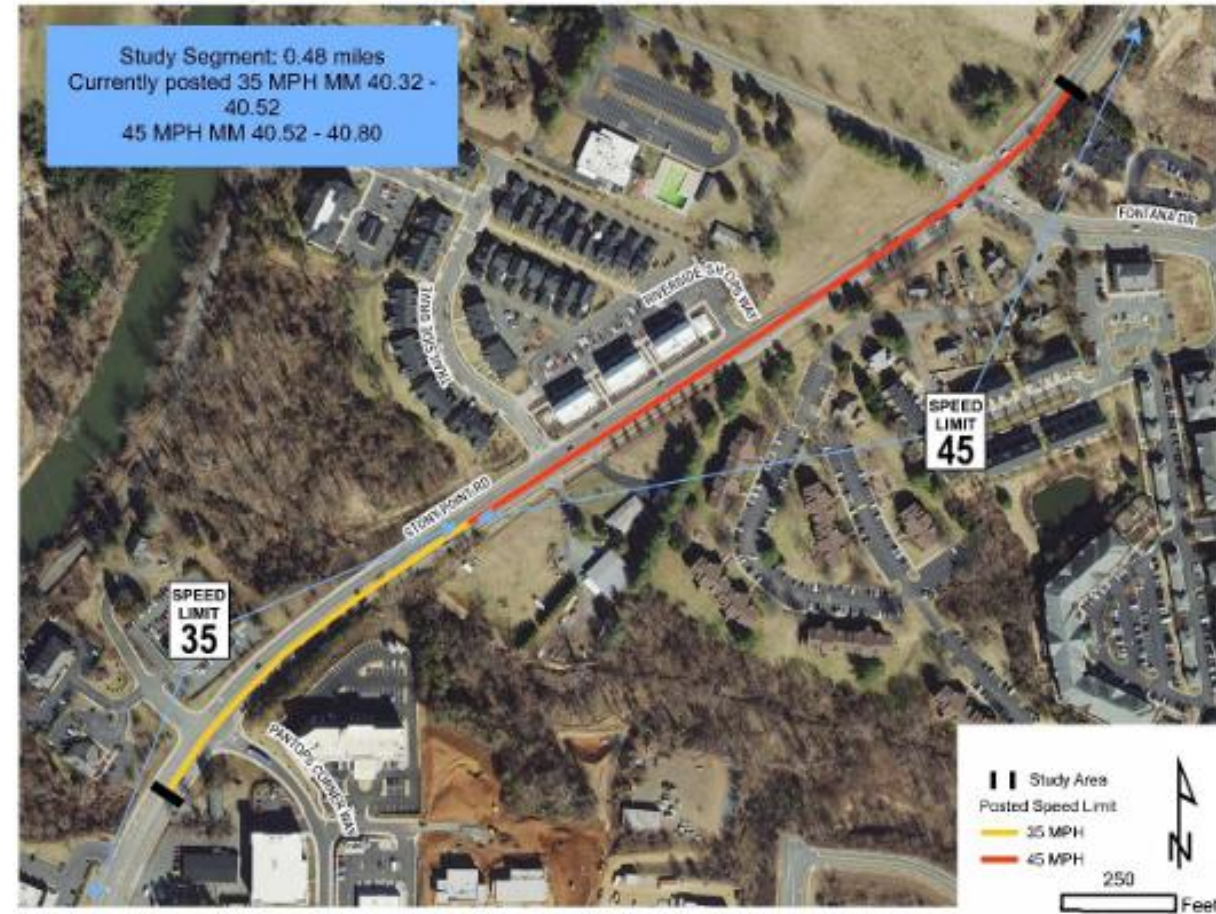
- **Crash history data from 10/1/19 – 10/31/24**
- **24 total crashes in the study area:**
 - **1 pedestrian fatality and 3 serious injuries**
 - **1 visible injury**
 - **5 possible non-visible injury**
 - **17 property damage only**
- **Two-thirds of the crashes occurred in daylight and 92% with no adverse weather conditions and on a dry pavement surface**
- **Speed was indicated in 2 of the crashes**

35 mph
4 crashes, 0 injury, 0 fatality

45 mph
20 crashes, 6 injury, 1 fatality

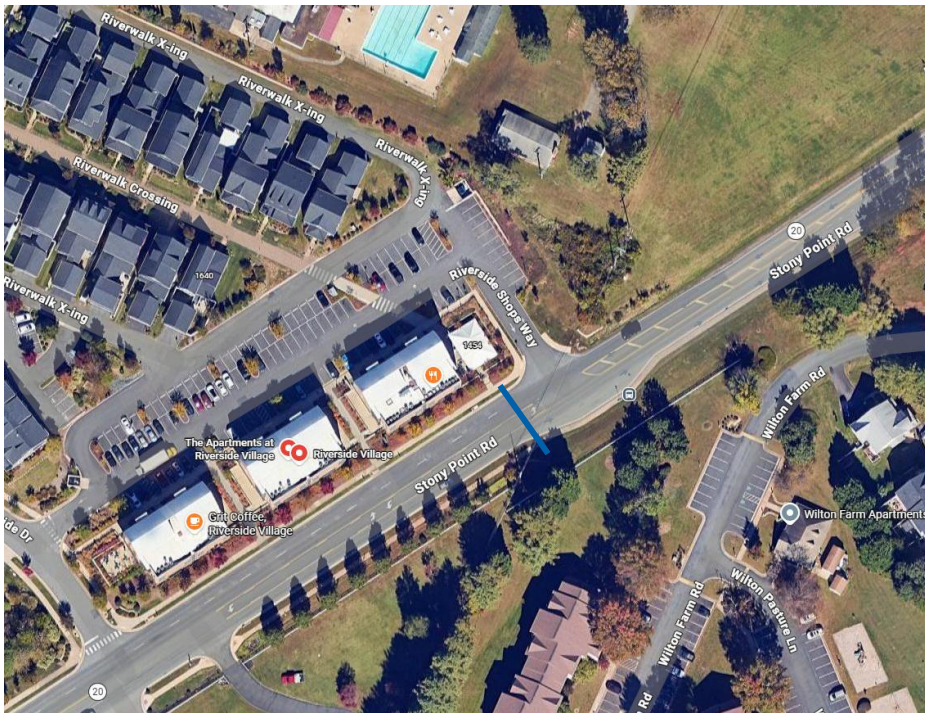
- Route 20 is classified as a Minor Arterial
- Existing Average Daily Traffic Volume of ~12,400 vehicles per day

Northbound
85th percentile speed 52 mph
Vehicles Sampled 16,128

Southbound
85th percentile speed 47 mph
Vehicles Sampled 20,505

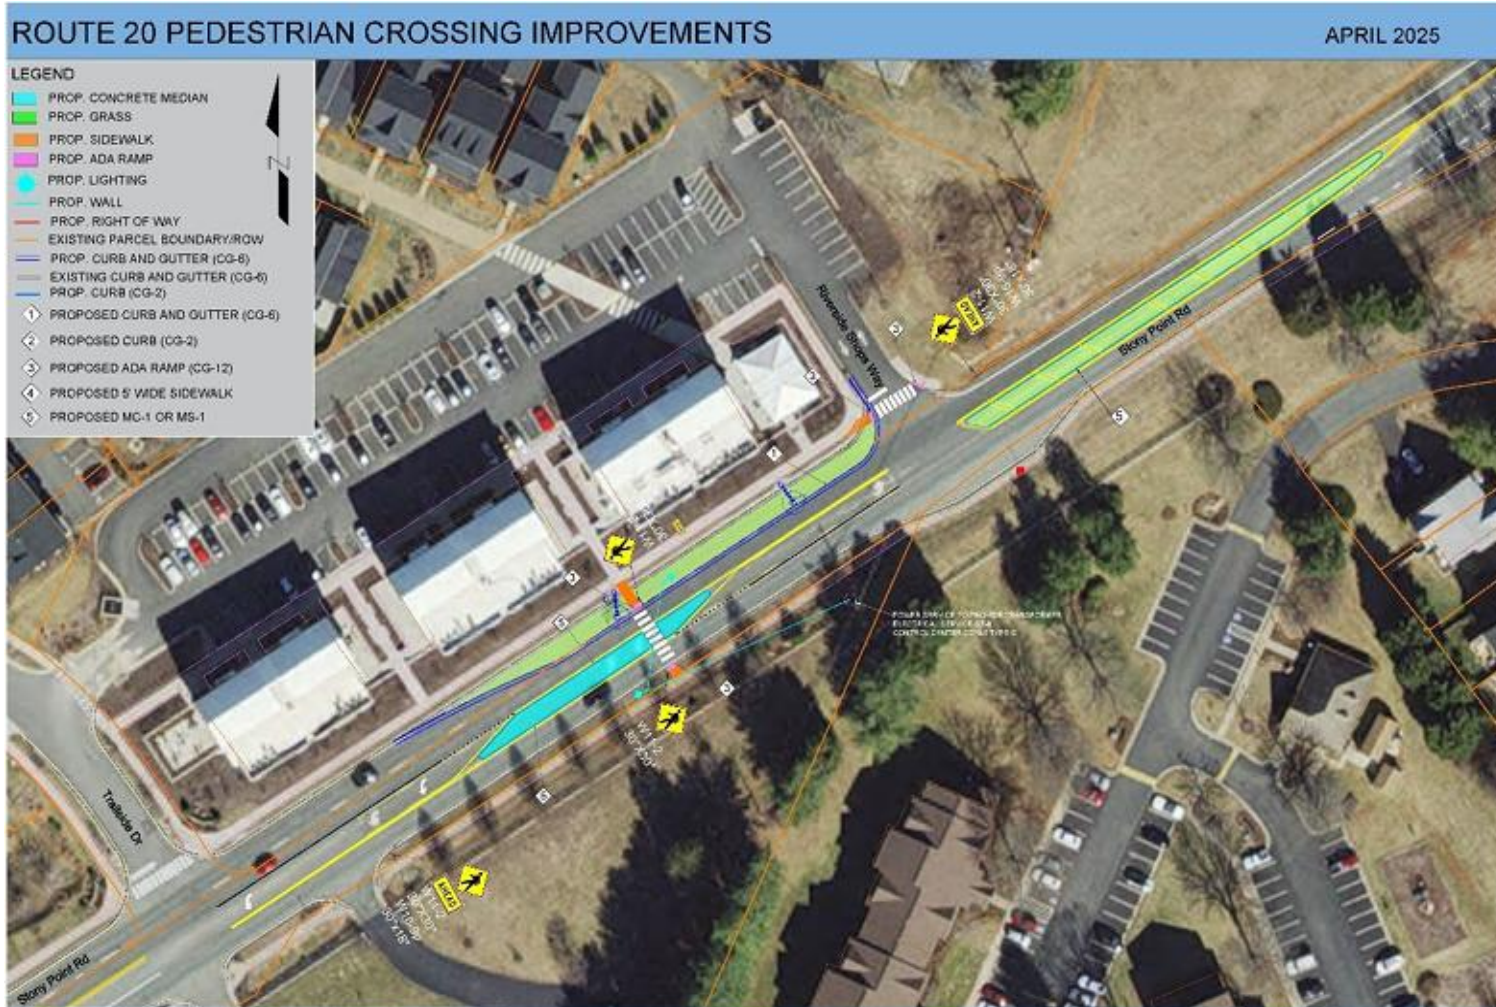
- New mid-block crosswalk
- Concrete median as refuge in center of Route 20
- Retain single southbound through lane until past the crosswalk
- Rapid flashing beacon for crosswalk
- Increase length of 35 mph zone
- Lighting and signage
